Hidden Unknowns - Drop in Mechanical Efficiency

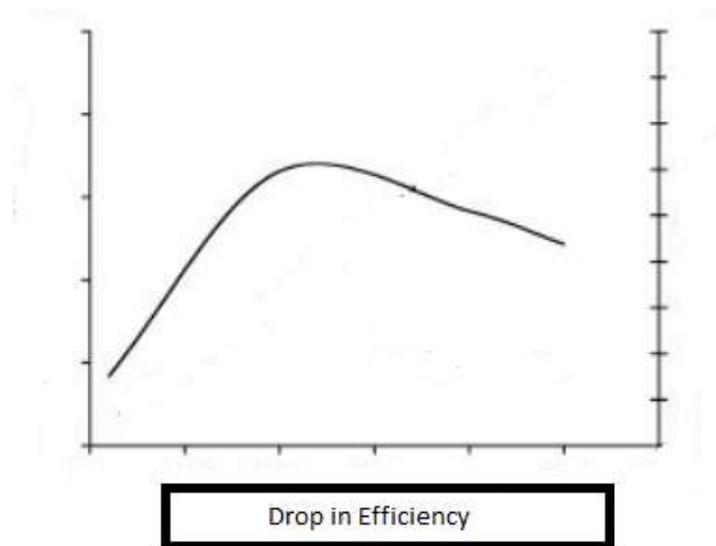
Ship left the port and faced the same challenge upon reaching the open sea.

During the sea trail vessel was achieving 99.4 RPM and pump mark was 75mm where Fuel consumption was 42 MT/Day. When benchmarked with the Sea trail, Vessel RPM was 90 RPM with consumption as 45.36 MT/Day with a pump mark of 85mm.
